Wyatt Sanders Home Inspections

Your Property Inspection Report

2378 South Ivy Ave, Fresno, CA 93706
Inspection prepared for: Sample Sample
Real Estate Agent: Sample Sample - Sample

Date of Inspection: 10/6/2023 Time: 9:00AM
Age of Home: 1930 Size: 900 sqft
Weather: Sunny

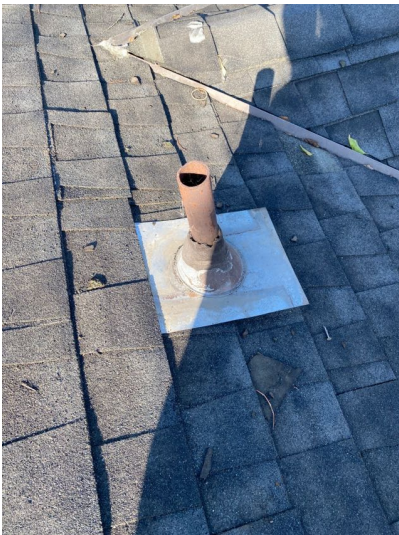
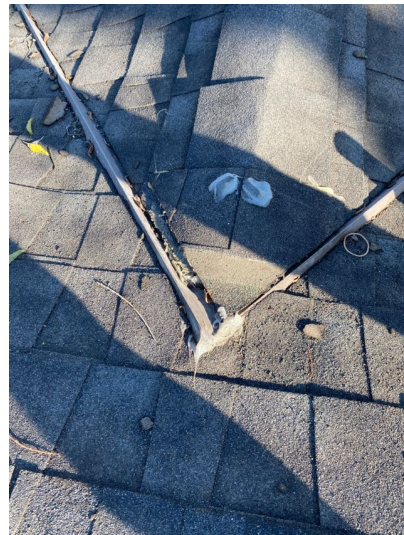
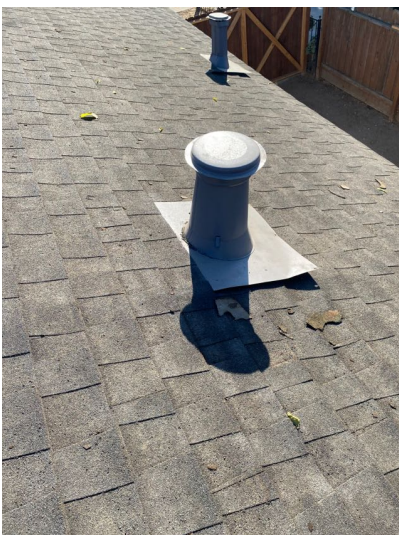
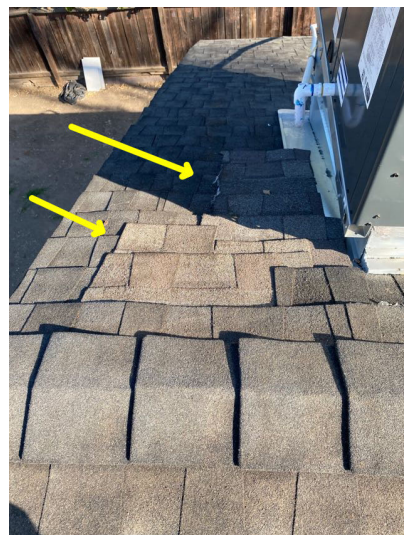
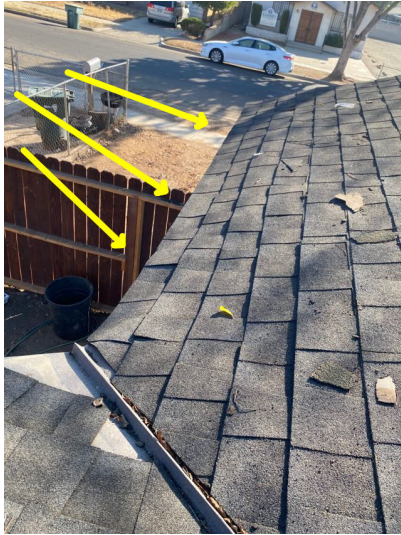
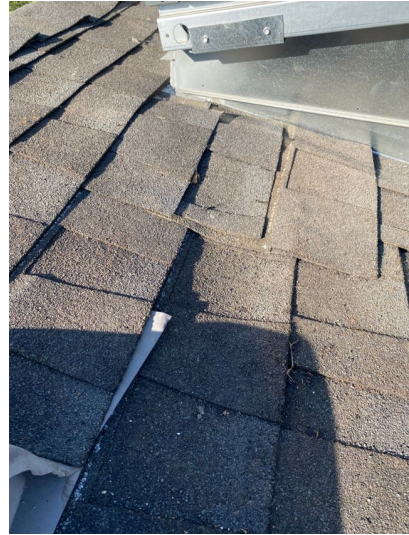
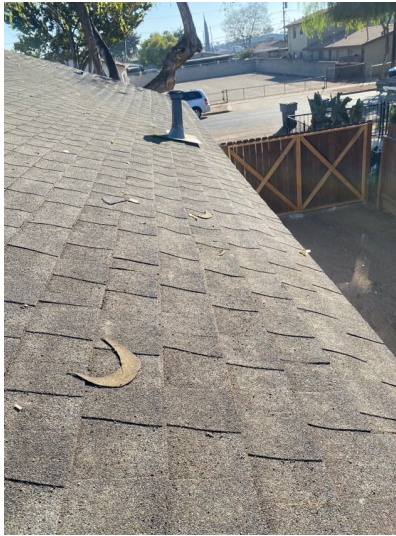
1. Roof

- Some shingles damaged.
- Flashing around homes exhaust and vents are not fully secured. This could allow moisture to penetrate roof structure.
- Some shingles are damaged and curling.
- Sagging / buckling on roof decking. Recommend having a licensed roofer evaluate roof structure.
- Exposed nails on roofing material. Recommend sealing all fastener heads.

Exterior Areas		
Page 5 Item: 1	Roof	<ul style="list-style-type: none"> • Flashing around homes exhaust and vents are not fully secured. This could allow moisture to penetrate roof structure. • Some shingles are damaged and curling. • Sagging / buckling on roof decking. Recommend having a licensed roofer evaluate roof structure. • Exposed nails on roofing material. Recommend sealing all fastener heads.
Page 10 Item: 7	Electrical, Exterior	<ul style="list-style-type: none"> • Outlet on exterior of home near backyard entrance has no weather protective cover and appeared to not be GFCI protected.
Page 10 Item: 8	Doors	<ul style="list-style-type: none"> • Backyard entrance doors top lock would not fully enter locked position.
Garage, Basement & Attic		
Page 12 Item: 2	Attic	<ul style="list-style-type: none"> • Roof supports members appeared damaged/aged. • Insulation averages 2 to 4 inches with some areas having no insulation installed. Recommend installing more. • Multiple areas of roof sheathing have damages. • Kitchen exhaust is not fully installed and is allowing exhaust to be deposited into attic space. • Electrical Box Covers missing or damaged. This leaves wires exposed which is an electrical hazard. • Bathroom exhaust fan duct appears to terminate in attic. Have duct routed to exterior to minimize moisture an possible development of mold.

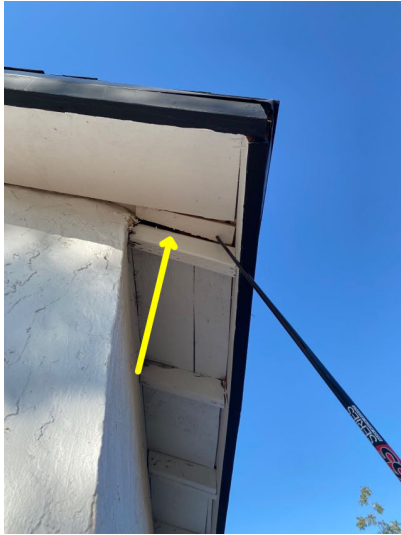
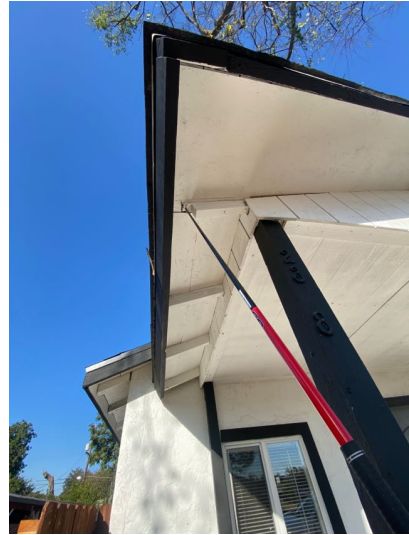
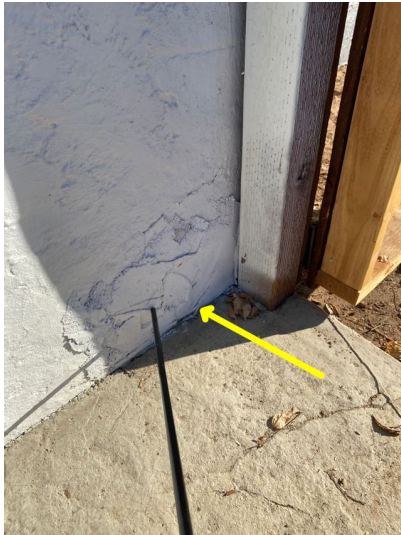
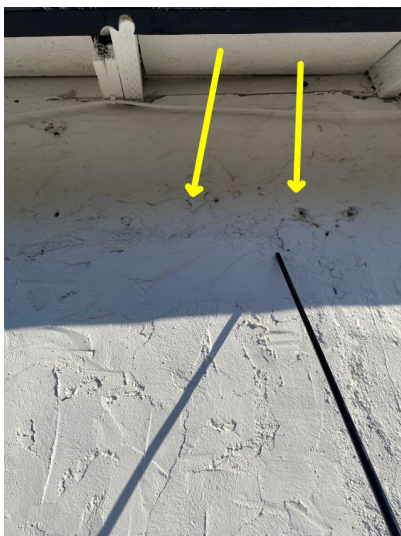
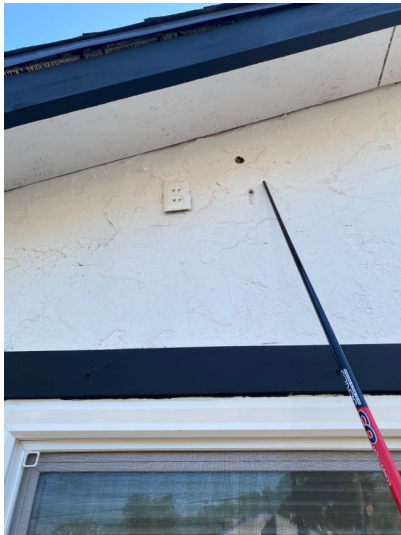
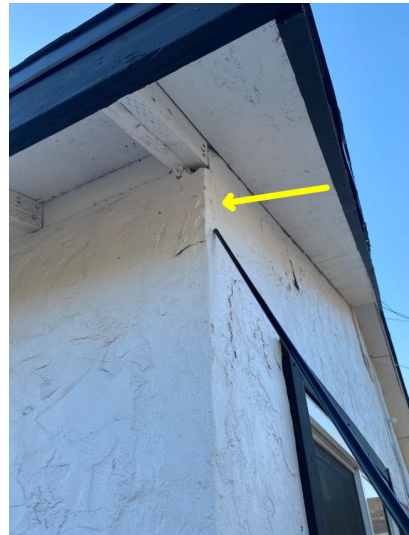
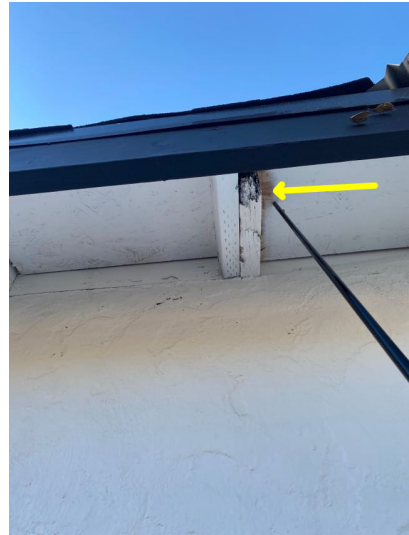
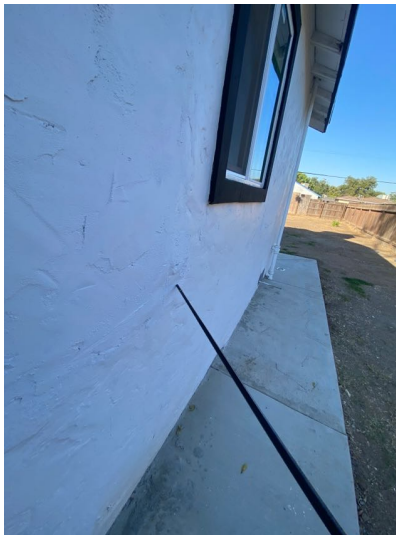
4. Siding

- Minor damages to soffit and fascia boards around home.
- Minor stucco siding damage noted.
- Small portion of drip edge missing on north side of home.

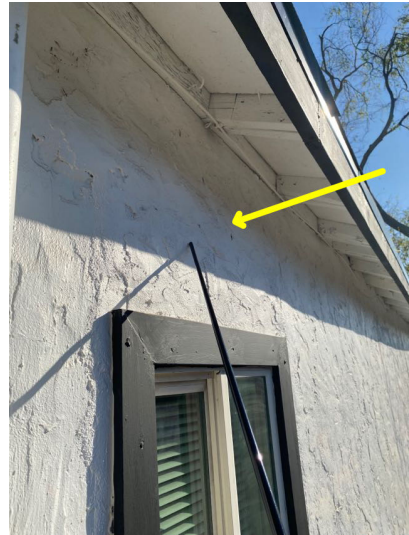
Stucco appears to be separating or bulging.

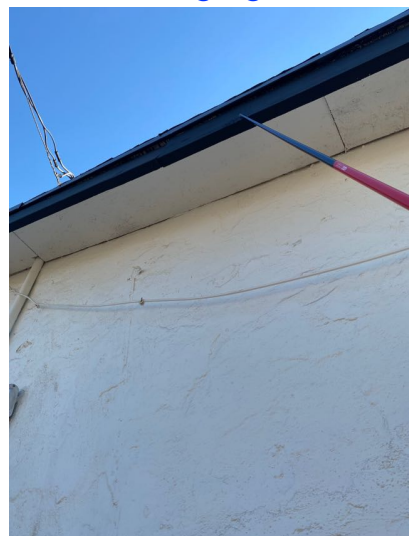
Exposed roof sheathing on west side of home

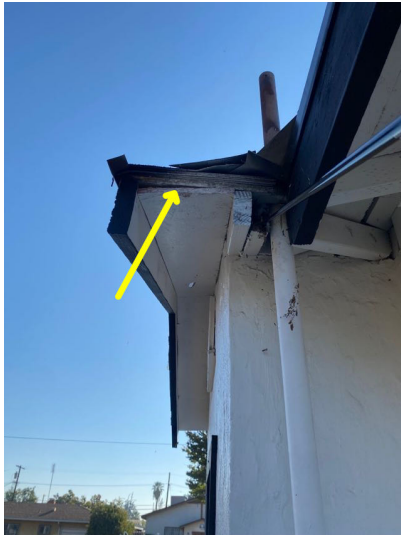
Drip edge missing on north side of home

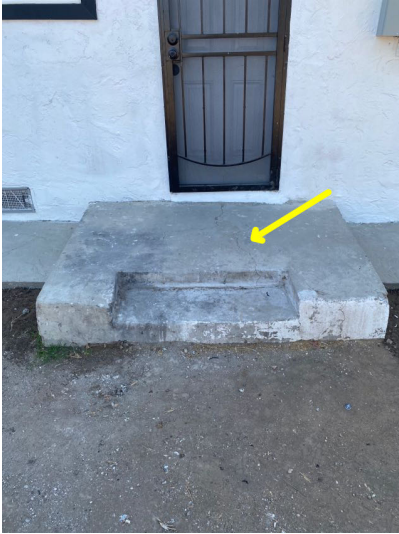
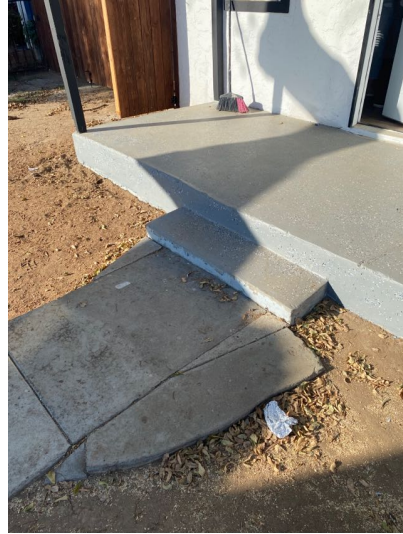
6. Decks & Steps

- No major system safety or function concerns noted at time of inspection.
- Minor cracking to steps noted.

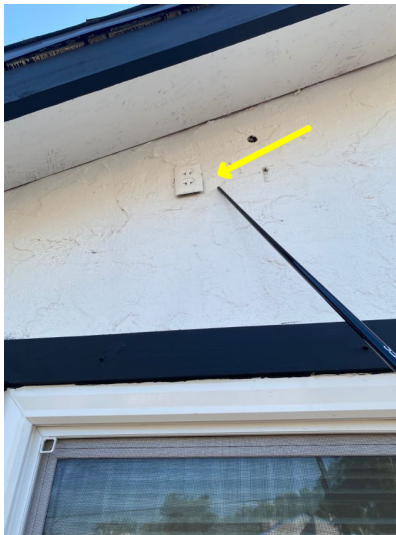
Exterior outlet near homes back entrance

- Outlet on exterior of home near backyard entrance has no weather protective cover and appeared to not be GFCI protected.

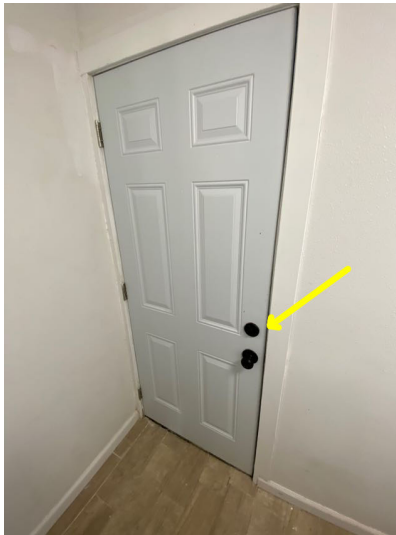
Homes back entrance door

- Backyard entrance doors top lock would not fully enter locked position.

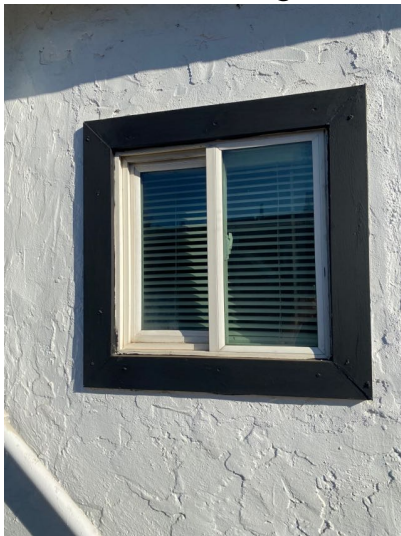
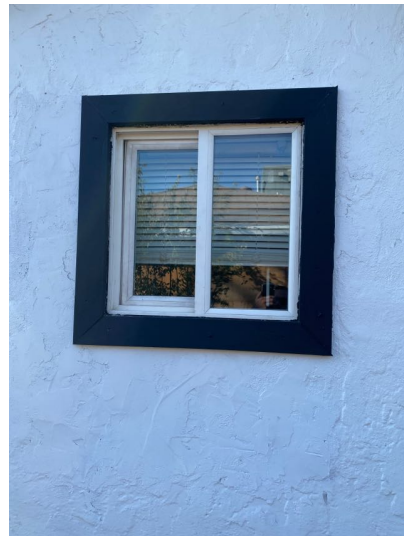
9. Window Condition

- Window screens missing.

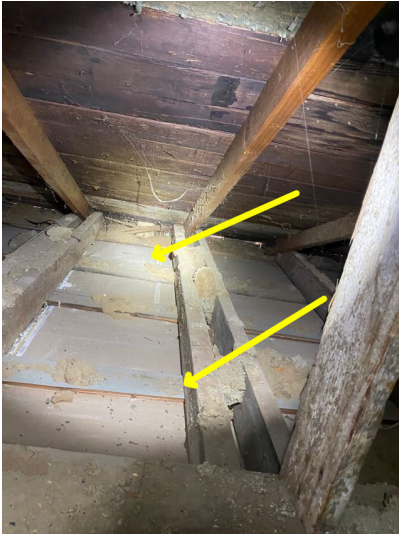
Missing insulation over living room

- No insulation over attic hatch; recommend installation, then sealing hatch with caulk to minimize heat loss.
- HVAC ducting supports are not secured.
- Multiple areas of roof structure appear to have past moisture staining but appeared to be dry at time of inspection.
- Roof supports members appeared damaged/aged.
- Insulation averages 2 to 4 inches with some areas having no insulation installed. Recommend installing more.
- Multiple areas of roof sheathing have damages.
- Kitchen exhaust is not fully installed and is allowing exhaust to be deposited into attic space.
- Electrical Box Covers missing or damaged. This leaves wires exposed which is an electrical hazard.
- Bathroom exhaust fan duct appears to terminate in attic. Have duct routed to exterior to minimize moisture an possible development of mold.

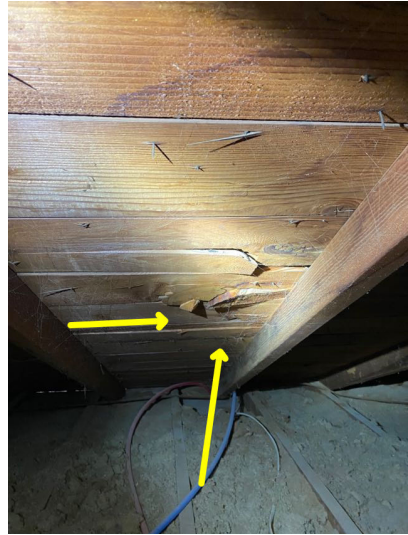
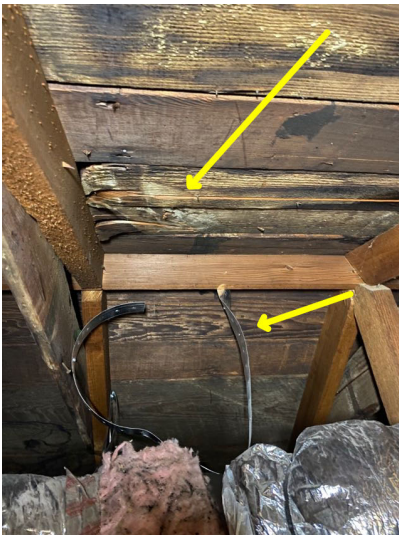
Damaged roof sheathing

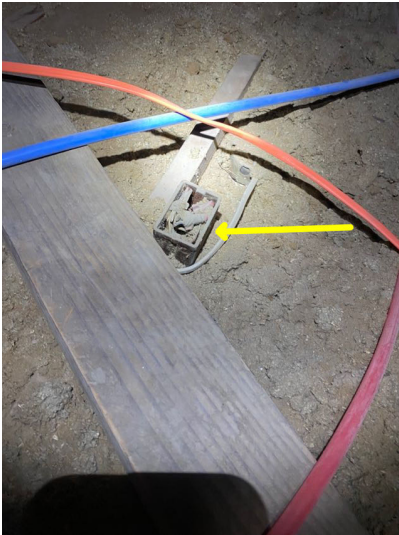
Open electrical box

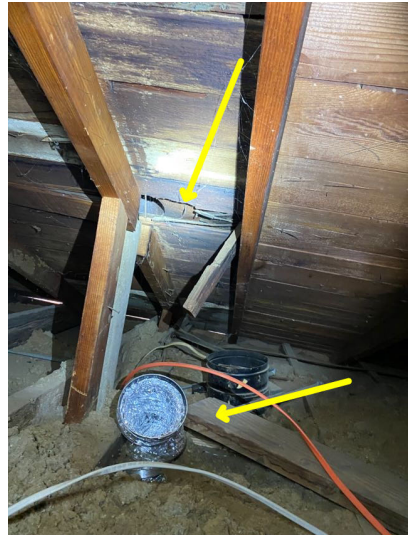
Kitchen exhaust ducting

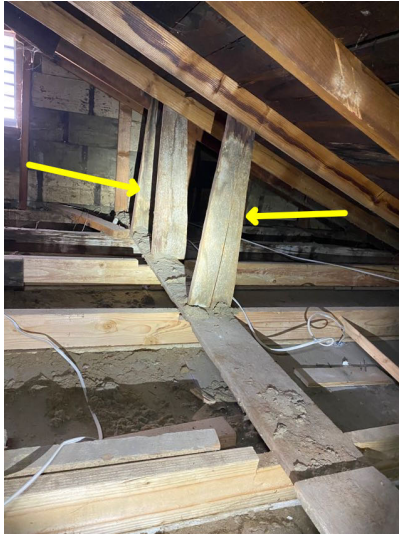
Roof supports

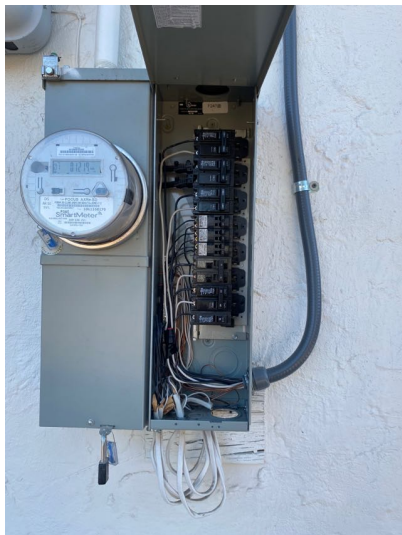
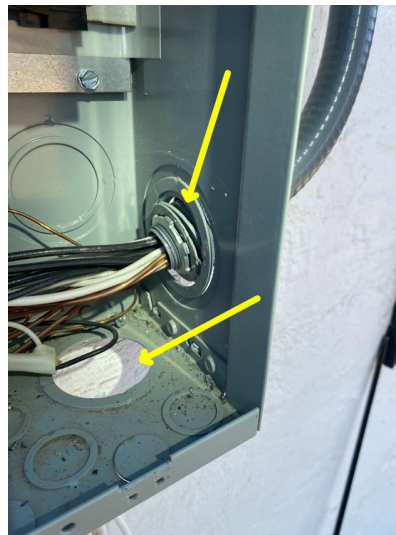
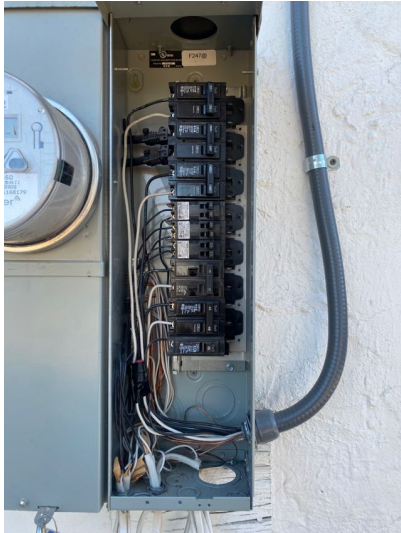
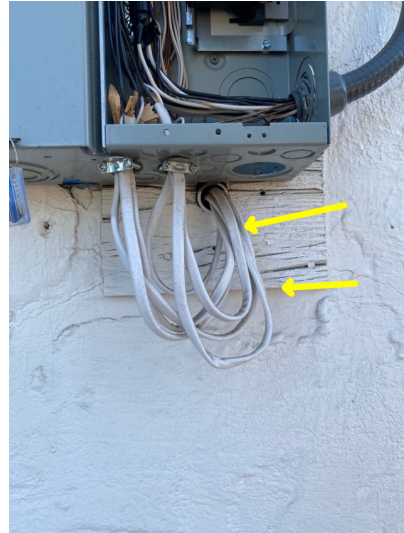
1. Electrical Panel

- Access hole on bottom of service panel is missing. This will allow for dirt and moisture intrusion if not covered.
- Panel cover missing, exposing live electrical wires.
- Wires entering service panel are not protected by conduit.
- Conduit is not fully sealed to service panel.

Page 15 Item: 1	Electrical Panel	<ul style="list-style-type: none">• Access hole on bottom of service panel is missing. This will allow for dirt and moisture intrusion if not covered.• Panel cover missing, exposing live electrical wires.• Wires entering service panel are not protected by conduit.• Conduit is not fully sealed to service panel.
Page 17 Item: 3	Water Heater	<ul style="list-style-type: none">• Temperature – Pressure drain line is missing. One should be installed to terminate within six inches of the floor to minimize personal injury which may be caused by scalding water, in the event of a pressure blow-off.• Earthquake strapping/bracing is missing.

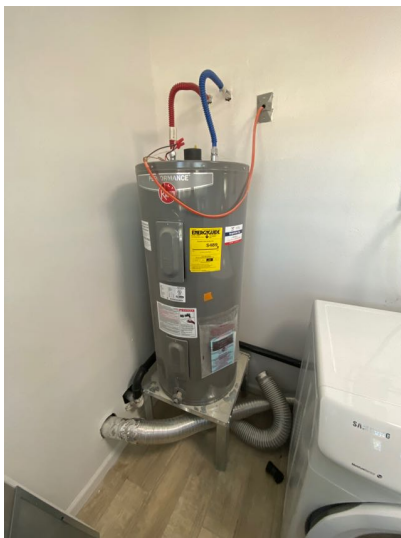
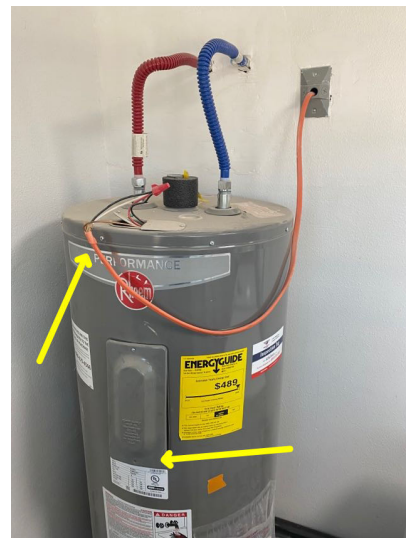
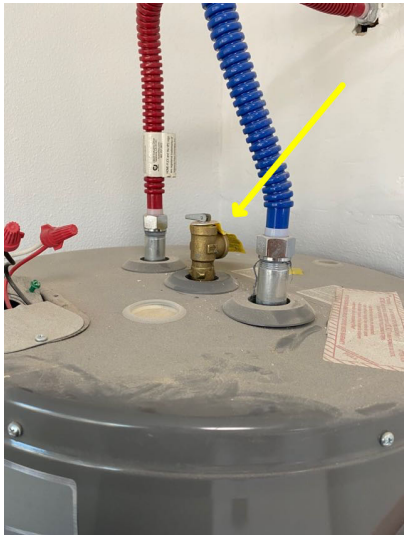
3. Water Heater

- Cover plate is missing hardware .
- No Catch Pan and Drain: Water heater is installed over finished living space. Consider installing pan.
- Wire to water heater is unsecured.
- Temperature – Pressure drain line is missing. One should be installed to terminate within six inches of the floor to minimize personal injury which may be caused by scalding water, in the event of a pressure blow-off.
- Earthquake strapping/bracing is missing.

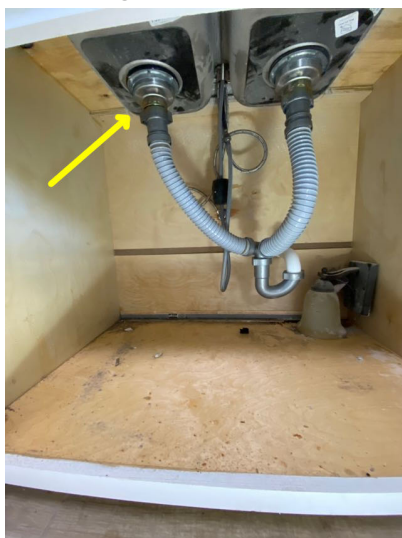
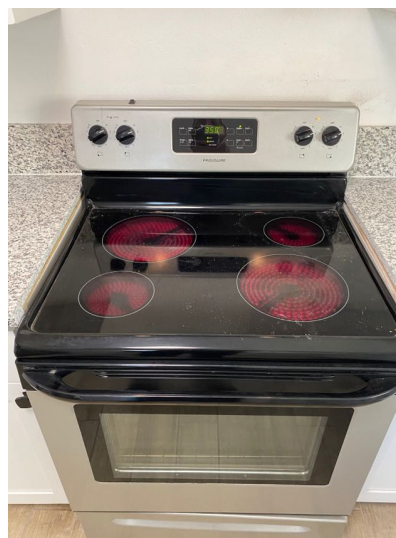
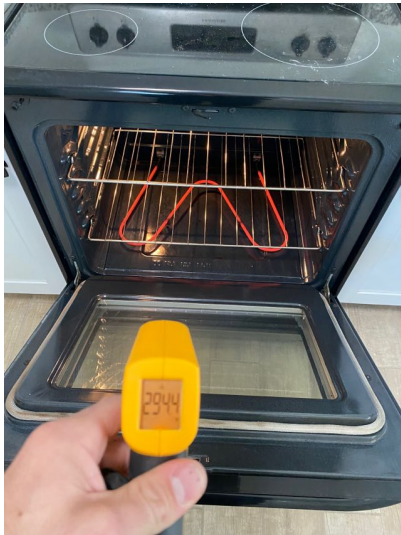
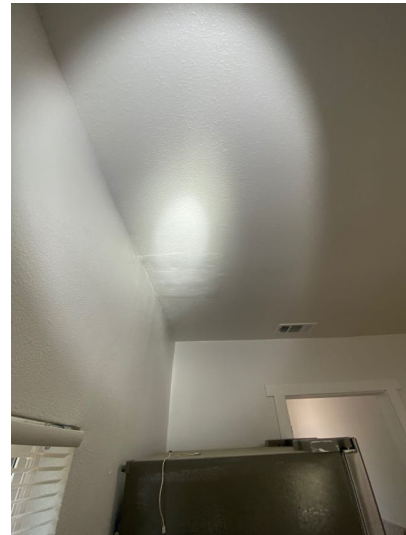
1. Kitchen

- Kitchen Appliances were operational at time of inspection.
- Repairs to ceiling noted.
- Drain plumbing leak under left hand sink noted.

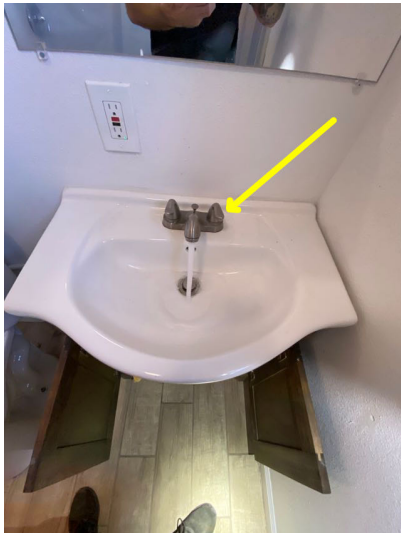
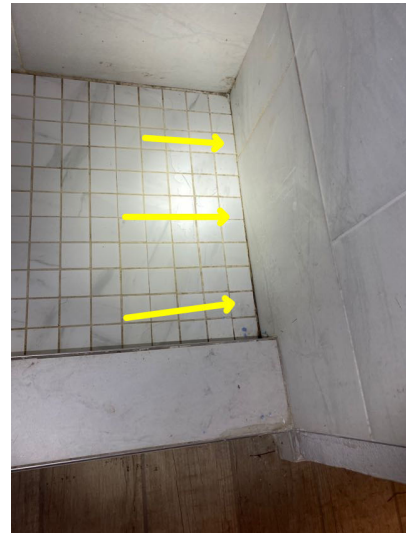
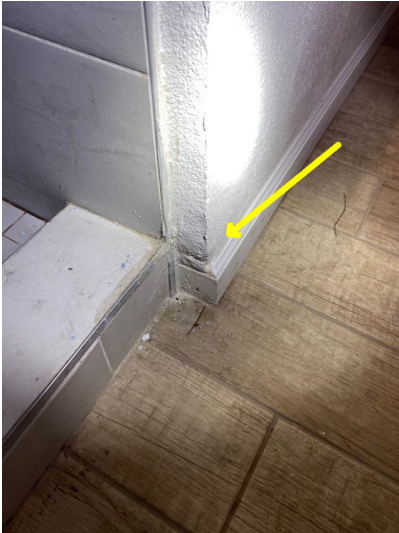
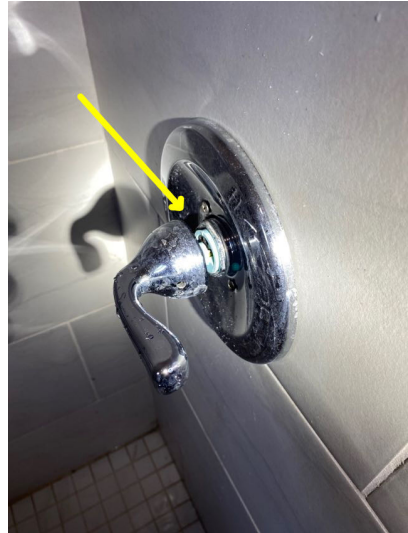
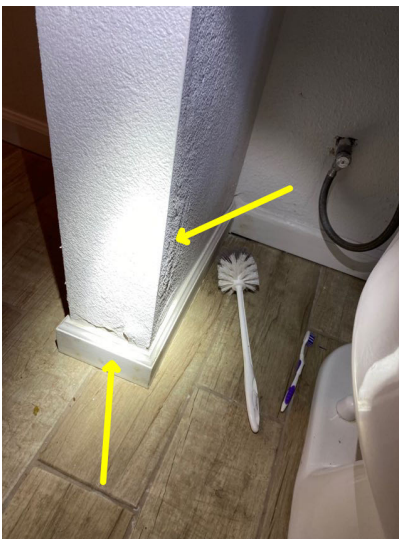
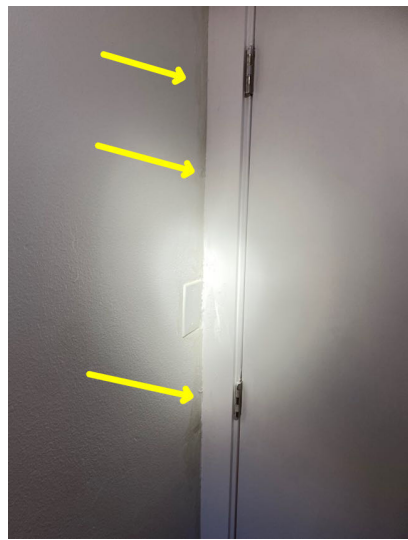
2. Bath

- LOCATION: Hallway full bath
- Sink faucet is loose.
- Damaged shower surround materials.
- Shower faucet is not fully installed.
- Repair work noted to walls around bathroom.
- Recommend adding caulking to bottom of shower to avoid unseen water penetration.

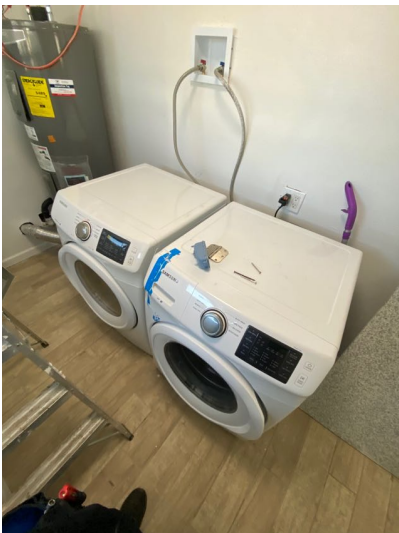
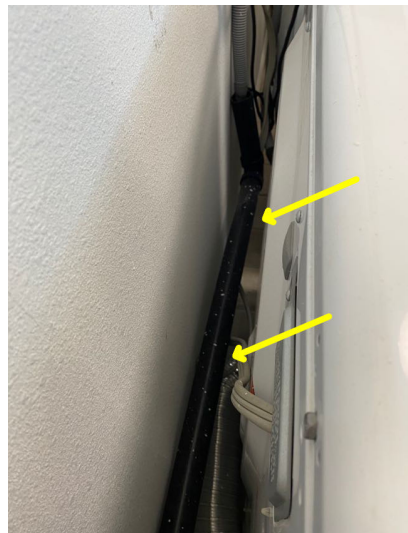
3. Plumbing & Laundry

- Washing machine drain plumbing is not being secured in place.

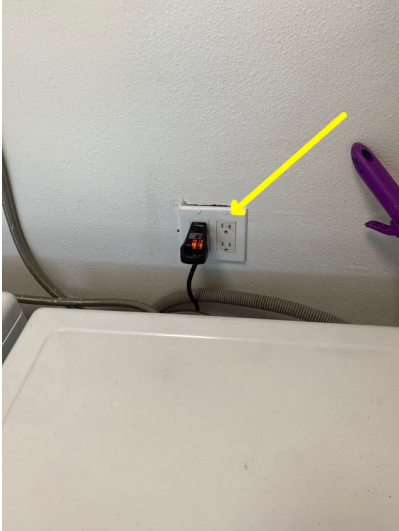
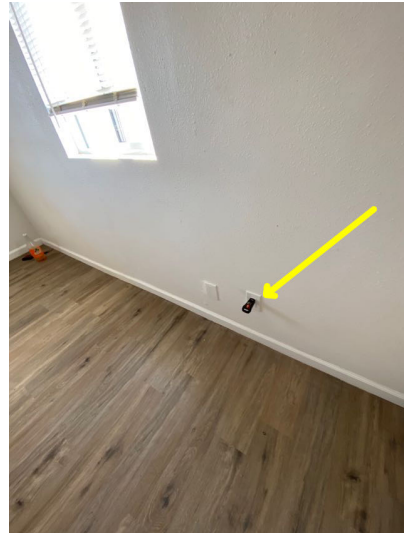
South living room wall

- Outlet behind washing machine is not GFCI protected.
- Outlet in living room has an open ground wire fault.
- Multiple outlets in home east side bedroom are not fully installed.
- No carbon monoxide detector present.

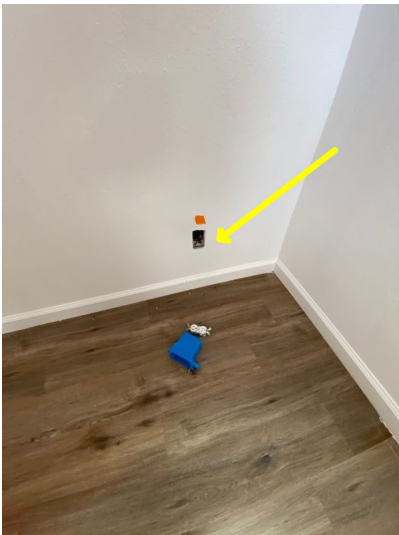
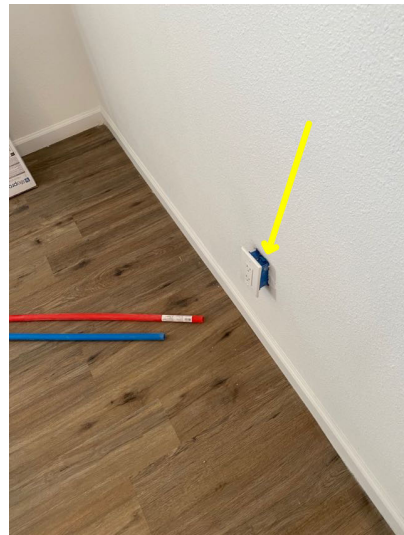
Master bed (east bedroom) west wall

Master bed (east bedroom) south wall

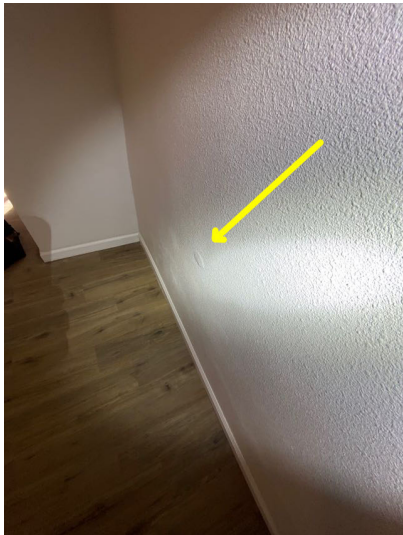
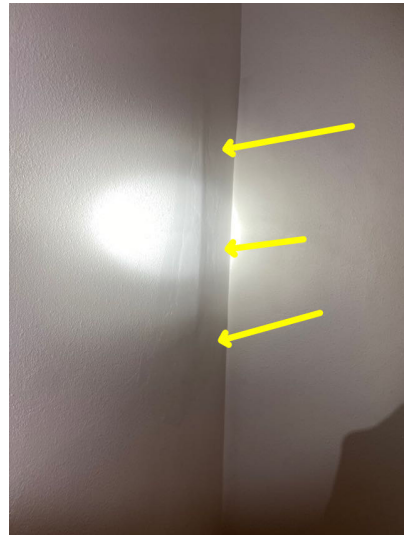
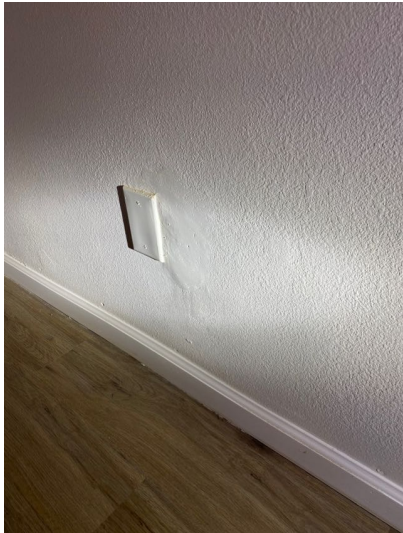
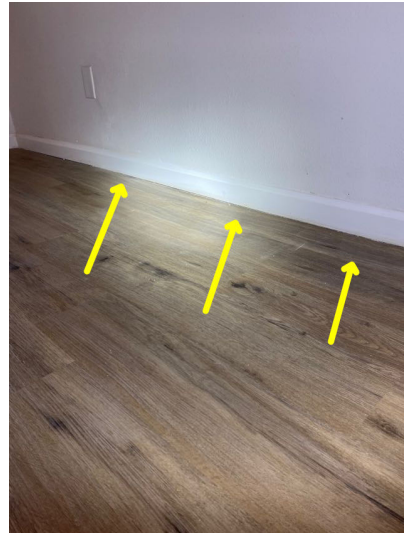
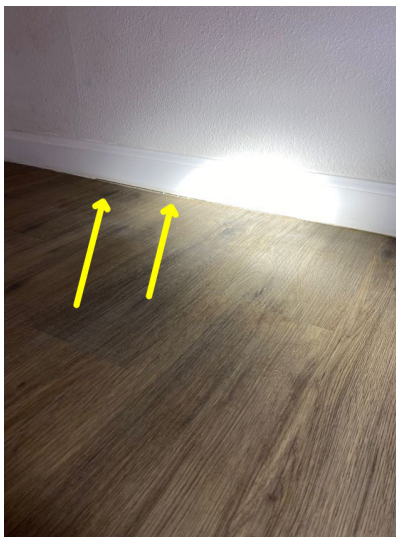
5. Floors, Ceilings & Walls

- Wall in homes west side bedroom has evidence of past moisture damages with a repair noted to wall.
- Homes floor appears to be uneven or sloping.
- Multiple walls around home appear to have been repaired.
- Minor baseboard separation noted.
- Fresh paint was observed. Although it improves the appearance, it may conceal any possible defects or prior repairs.

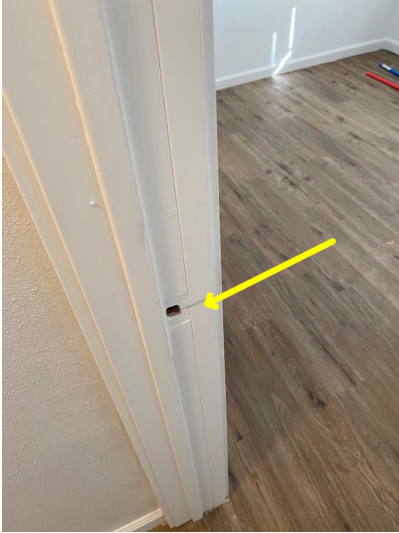
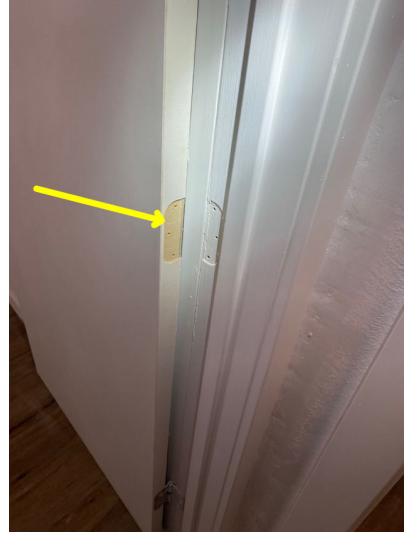
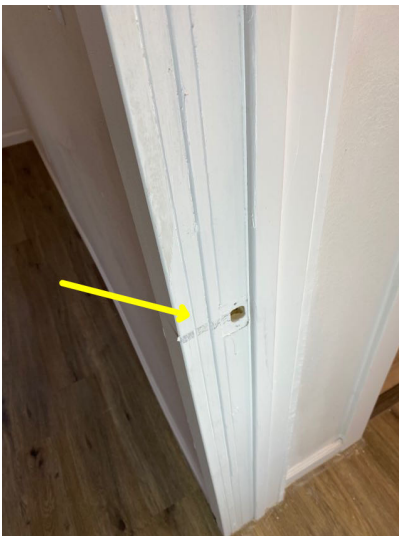
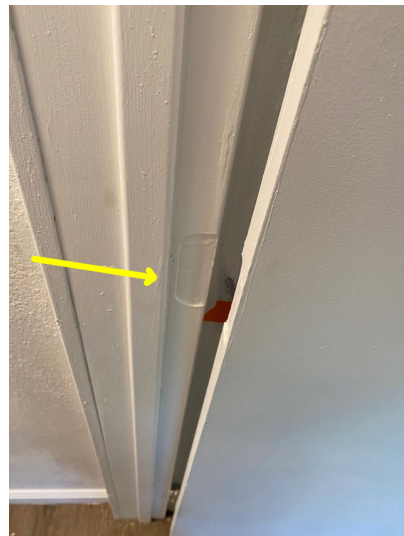
6. Doors

- Door to east bedroom is missing striker plate and door hinges.
- Door to west bedroom is missing striker plate and door hinges.
- Some door stop(s) missing / ineffective; recommend installation to avoid unnecessary wall or door damage.

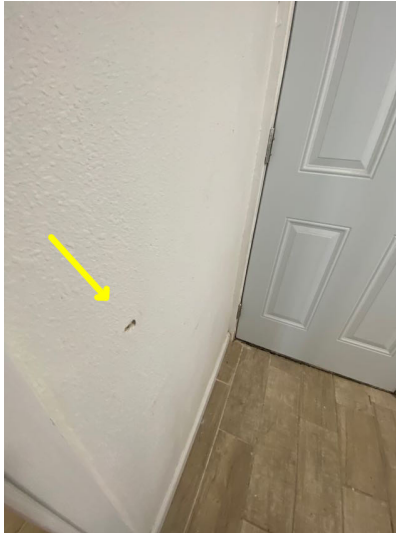
Back entrance door is missing door stop.
